Holly, MI

Clogging Eliminated and Costs Reduced at Oak Hill Estates

The Barnes[®] SH Series Solution

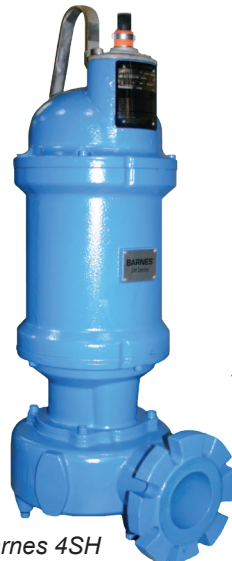
Barnes 4SH

Jett Pump & Valve recommended a Barnes 4SH non-clog 7.5HP pump with vortex impeller manufactured by Crane Pumps & Systems. The troubled treatment plant is now operating maintenance free.

- Allows 3" solids handling capability and handles stringy solids at low flows.
- Volute designed to allow impeller to form a vortex which passes 98% of the solids without coming into direct contact with the impeller.
- Impeller is specially designed to provide outstanding clog resistance from stringy and other difficult solids.

A Barnes 4SHV non-clog 7.5HP pump with vortex impeller was installed. The slotted discharge flange allowed the pump to be installed to the existing discharge piping with no modifications required.

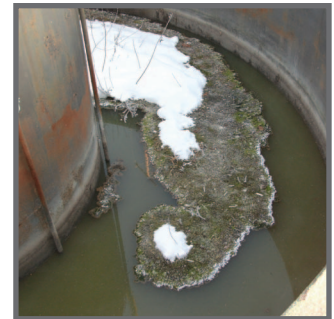
Large sewage raft from equalization basin

Frequent clogging caused by large raw sewage solids required inconvenient and repetitive service calls, often during overnight hours and inclement weather.

The pump was clogging multiple times a week, sometimes causing the pump motor to overheat and fail requiring even more repair maintenance and potential for the tank to overflow.
