Salem Lakes, WI

MUNICIPALITY OVERVIEW:

LIFT STATION DETAILS:

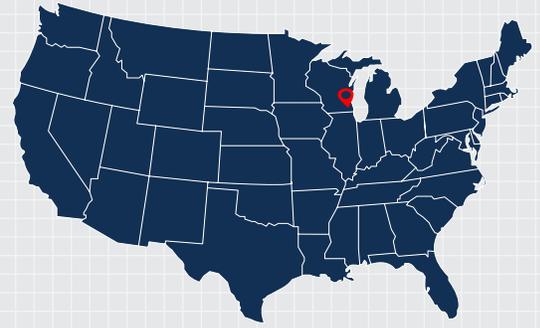
Barnes White Iron Impeller

The ductile iron vortex impellers of the pumps in station 18 were wearing out frequently due to abrasive particles in sewage. The worn-out impellers were catching rags and stringy solids in the sewage, which increased costs of deragging and pump cleaning. Due to the station's inherent design, pump cleaning required confined space entry into the station rather than removal of the pump. Since the ductile iron impellers were lasting only a few months, they had to be replaced often requiring frequent confined space entries. Repeated impeller replacements cost servicing time and necessitated the municipality to keep inventory of spare impellers. In addition to replacement and servicing costs, worn-out impellers were also negatively impacting flow rate and pump efficiency.

- Existing impellers were wearing out frequently due to abrasive particles
- Impellers were catching rags & stringy solids, which led to excessive deragging and pump cleaning costs
- Cleaning the pumps required confined space entry into the station
- Worn-out impellers were negatively impacting flowrate and pump efficiency

Crane Pumps & Systems and Energenecs Inc., a municipal distributor of Crane Pumps & Systems, recommended the Village of Salem Lakes to replace the existing ductile iron vortex impellers with the Barnes White Iron (25% High Chrome) impellers. Salem Lakes installed a Barnes White Iron impeller in one of the pumps in the station. After 6 months of continuous operation in the abrasive environment, the Barnes White Iron impeller has experienced no wear and continues to provide superior non-clogging and efficient performance. The pump does not require cleaning which eliminated the need for confined space entries. The Village of Salem Lakes is highly impressed with Barnes White Iron impeller solution and is planning to replace ductile iron impellers with Barnes White Iron impellers in the other two pumps in the station and in other stations handling abrasive solids.

- Barnes White Iron impeller installed to replace the existing ductile iron vortex impeller
- Pump has experienced no wear and continues to provide superior non-clogging and efficient performance
- Pump no longer requires cleaning or confined space entries
- Salem Lakes plans to replace other impellers in the station with White Iron Impellers
