Holly, MI  
Oak Hill Estates mobile home court, wastewater treatment plant outfitted with Flygt 3085 pump transferring raw sewage from equalization tank to batch reactor.

# Clogging Eliminated and Costs Reduced at Oak Hill Estates

## The Barnes® SH Series Solution

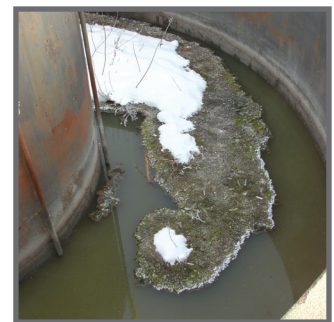
Frequent clogging caused by large raw sewage solids required inconvenient and repetitive service calls, often during overnight hours and inclement weather.

The pump was clogging multiple times a week, sometimes causing the pump motor to overheat and fail requiring even more repair maintenance and potential for the tank to overflow.

Large sewage raft from equalization basin

Jett Pump & Valve recommended a Barnes 4SH non-clog 7.5HP pump with vortex impeller manufactured by Crane Pumps & Systems. The troubled treatment plant is now operating maintenance free.

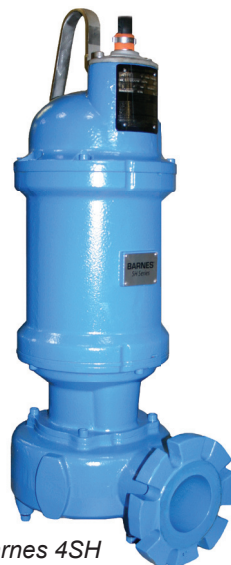
Barnes 4SH

- Allows 3" solids handling capability
- and handles stringy solids at low flows.
- Volute designed to allow impeller to form a vortex which passes 98% of the solids without coming into direct contact with the impeller.
- Impeller is specially designed to
- provide outstanding clog resistance from stringy and other difficult solids.

A Barnes 4SHV non-clog 7.5HP pump with vortex impeller was installed. The slotted discharge flange allowed the pump to be installed to the existing discharge piping with no modifications required.

The 4SHV pump has not clogged once since installation. Elimination of service calls and maintenance during inclement weather has resulted in significant costs savings and a safer working environment. Highland Treatment Inc., feels assured there is much reduced potential of the equalization tank overflowing, which would have resulted in substantial EPA fines.
